# Columela 6

## Consolidation - Refurbishment

Located in one of the best parts of the Salamanca neighborhood, only few meters from Serrano Street and Independencia Square, this building of about 4,000 m<sup>2</sup>, built in 1.883 and protected at the level of its structure, underwent an important work of consolidation.

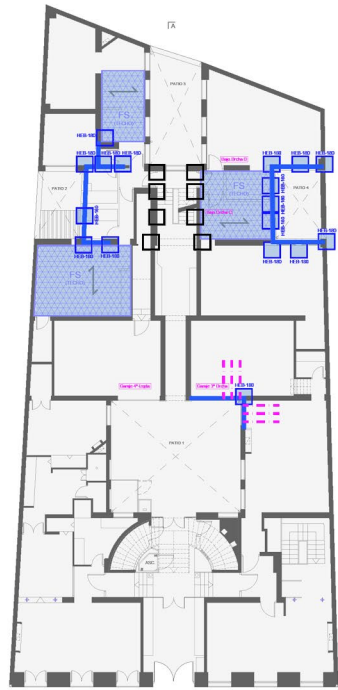
PLANTA BAJA. E: 1/100

PIE DERECHO CON AVANZADO ESTADO DE PUDRICION (A SUSTITUIR POR METALICO).

PIE DERECHO CON INICIO DE PUDRICION EN SU BASE (A RETACAR).

- A SUSTITUIR POR OTRO NUEVO METALICO TIPO HEB SEGUN DETALLE.  
(EN PLANTAS SOTANO, BAJA Y 1ª POR HEB-180)  
(EN PLANTA 2ª POR HEB-160)  
(EN PLANTA 3ª POR HEB-140)  
(EN PLANTAS 4ª Y 5ª POR HEB-120)

- A SERRAR LA BASE, CON COLOCACION DE BANDEJA INFERIOR DE CINCO CON BORDES DOBLADOS PARA EVITAR NUEVAS PUDRICIONES FUTURAS, RETACAR CON FABRICA DE LADRILLO PERFORADO TOMADA CON MORTEROS SIMILARES O COMPATIBLES CON LOS EXISTENTES Y ARENA DE RIO Y ACUÑADO DEL PIE DERECHO SANEADO CON CUÑAS DE MADERA Y RELLENO RELLENO INTERSTICIAL CON MORTERO SIN SIMILARES O COMPATIBLES CON LOS EXISTENTES SIN RETRACCION.

NUEVO FORJADO DE MADERA CON VIGUETAS DE MADERA DE PINO DE LA MISMA ESCUADRIA / 60 cm DE 10X20 A 15X25 DE SECCION + NERVOMETAL 5.5 mm + # Ø 5 mm 15X15 B500 + 4 cm H30.

NUEVO FORJADO METALICO FORMADO POR VIGUETAS IPE-160 / 70 cm + NERVOMETAL 5.5 mm + # Ø 5 mm 15X15 B500 + 5 cm H30.

SUSTITUCION DE CARRERA DE MADERA EXISTENTE EN MAL ESTADO POR CARRER METALICA HEB-160 (VER DETALLE N° 1).

ZUNCHADO DE CARRERA DE MADERA EXISTENTE EN BUEN ESTADO A 2 CARAS CON 2 UPN-180 EMPRESILLADOS o 1 UPN-180 + CHAPON 180.10 EMPRESILLADOS (VER DETALLE N° 3).

- CARRERA, VIGUETA O PAR DE CUBIERTA A CONSOLIDAR CON SANEADO DE PARTE PODRIDA Y COLOCACION DE NUEVA PROTESIS DE LA MISMA ESCUADRIA, CON CORTE DE AMBAS PIEZAS A 45° EN DIRECCION CONTRARIA AL SENTIDO DE APERTURA DE LA PIEZA AL FLECHAR. TRABADO DE AMBOS ELEMENTOS CON RESINA Y VARILLAS DE FIBRA DE CARBONO SEGUN LO ESPECIFICADO EN MEDICION PRESUPUESTO.
